Reserve Study Level I, Full

Vizcaya at Burnt Store Isle Condominium

Vizcaya at Burnt Store Isle Condominium
Punta Gorda, FL 33950

Reserve Study - Level I, Full For fiscal year starting on January 1, 2026

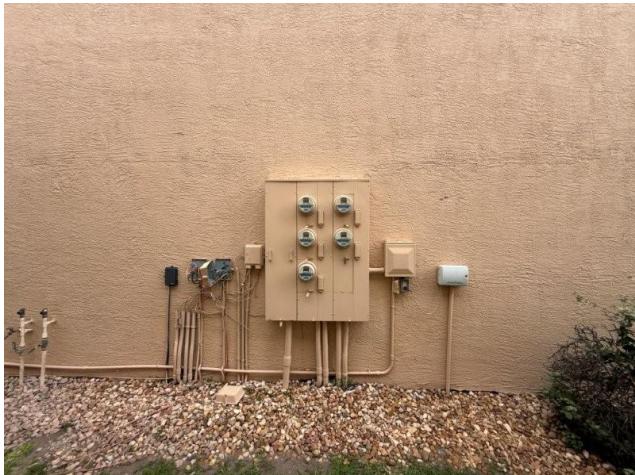
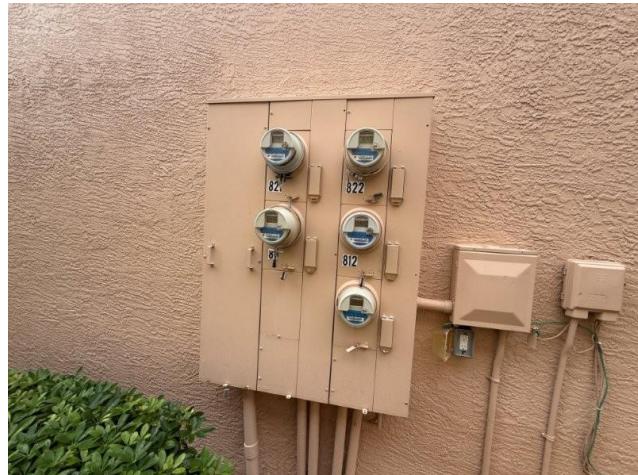
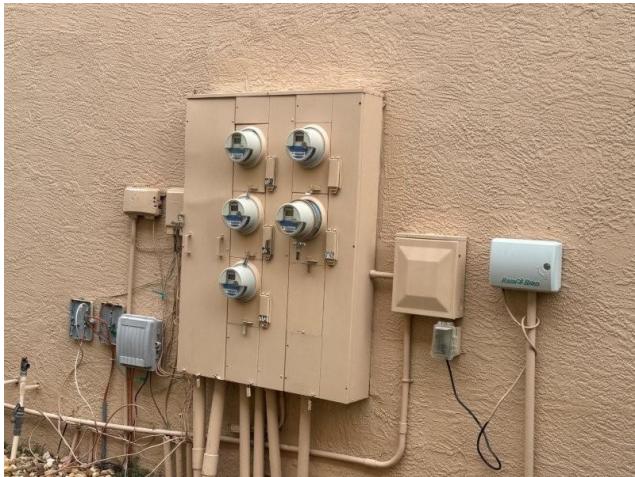
Basic Info		Cost Data		
Asset ID:	A01	Unit Cost (01/01/2026):	\$1,250.00	
Type of Cost:	Replacement	Total Qty to Maintain (100% of Total):	36 Ea	
Category:	Building Service Components	Total Current Cost:	\$45,000	
Sub Category:		Inflation Rate:	2.50%	
Est. Useful Life:	50y	Condition:	Good

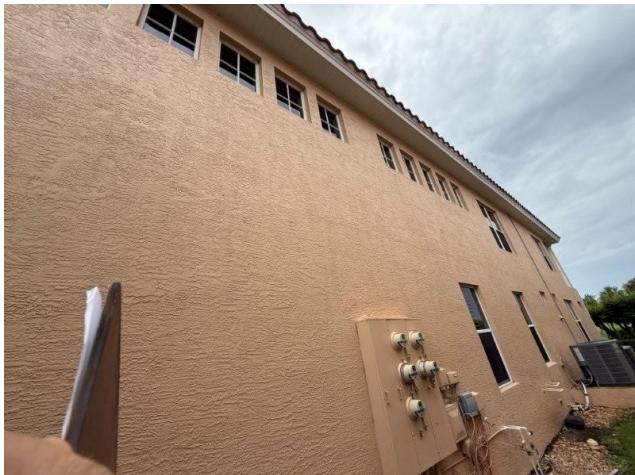
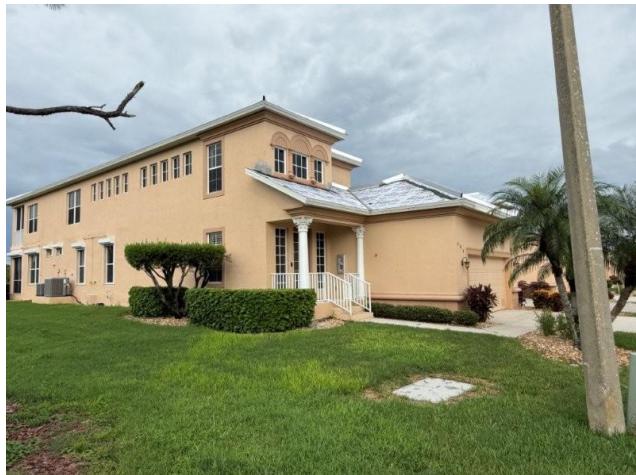
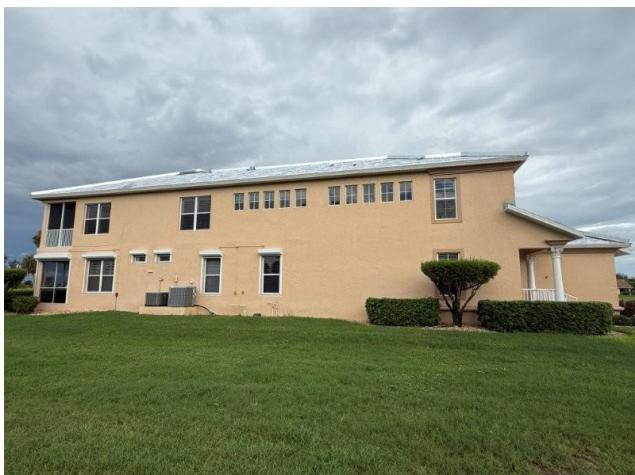
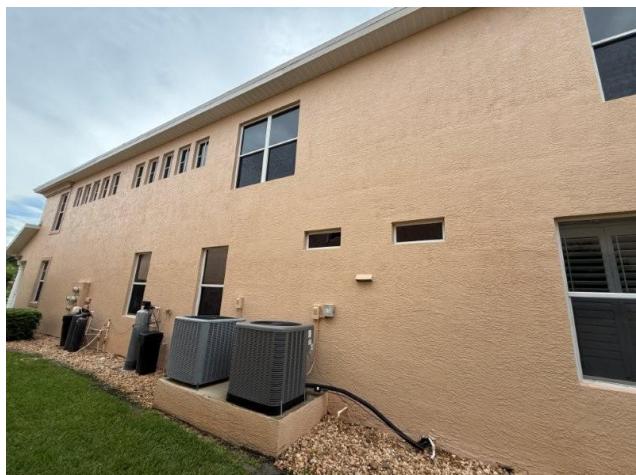
Exterior Paint & Waterproofing

Unit Cost (01/01/2026):	\$87,000.00
Total Qty to Maintain (100% of Total):	1 LS
Total Current Cost:	\$87,000
Inflation Rate:	2.50%
Condition:	Good

The cost basis for this reserve component was provided by the Board of Directors.

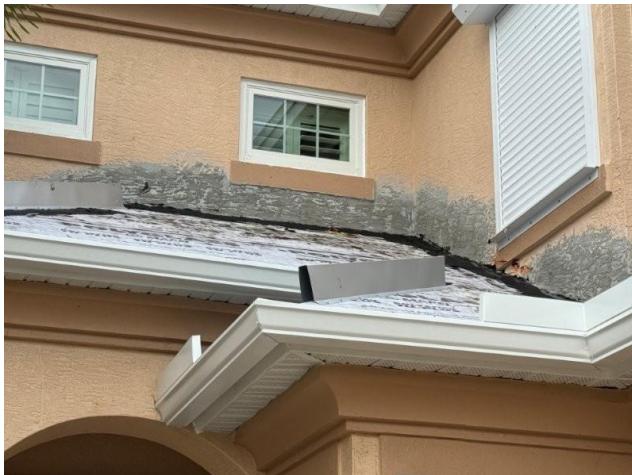
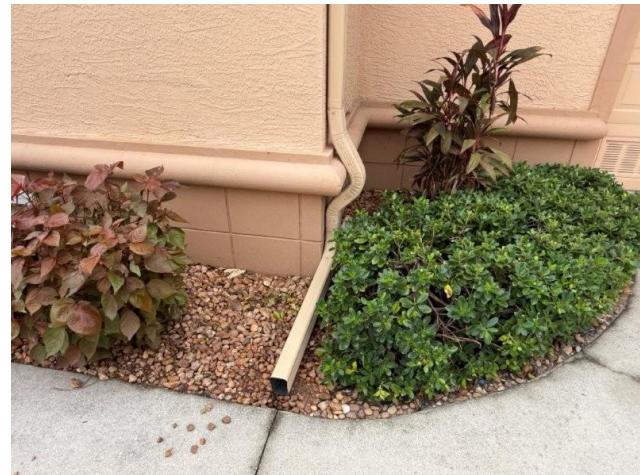
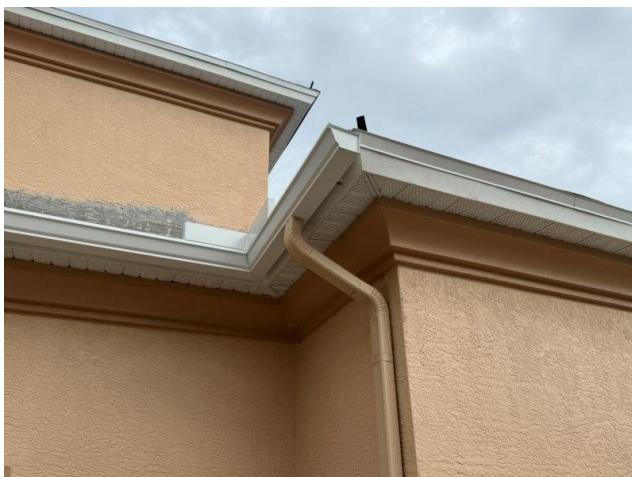
Gutters & Downspouts, 6" Aluminum

Basic Info		Cost Data	
Asset ID:	B02	Unit Cost (01/01/2026):	\$14.85
Type of Cost:	Replacement	Total Qty to Maintain (100% of Total):	890 LF
Category:	Exterior Building Components	Total Current Cost:	\$13,216
Sub Category:		Inflation Rate:	2.50%
Est. Useful Life:	30y	Condition:	Excellent

The cost basis for this reserve component is based off a contract dated 4/7/2025 from CWC Roofing.

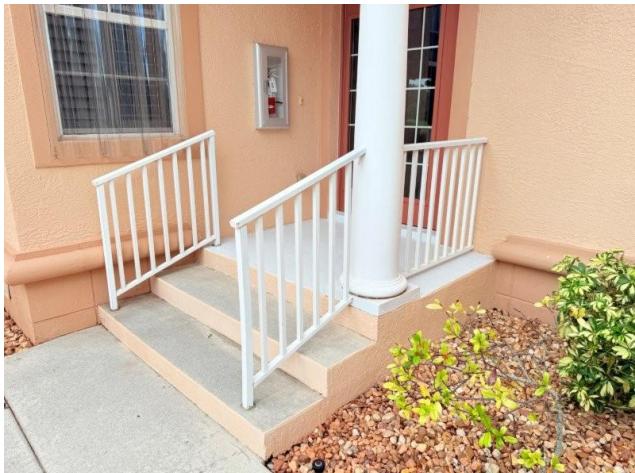
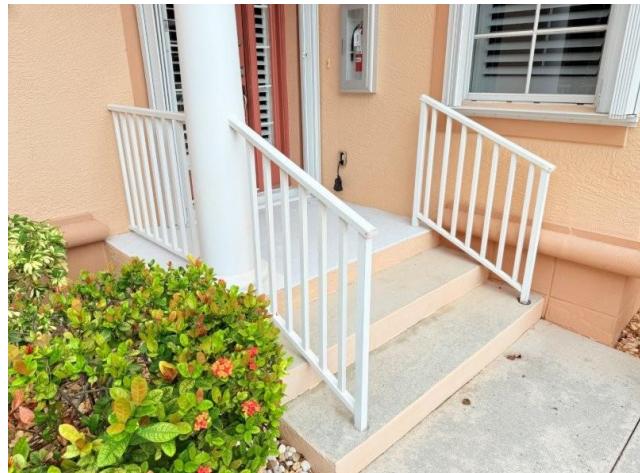
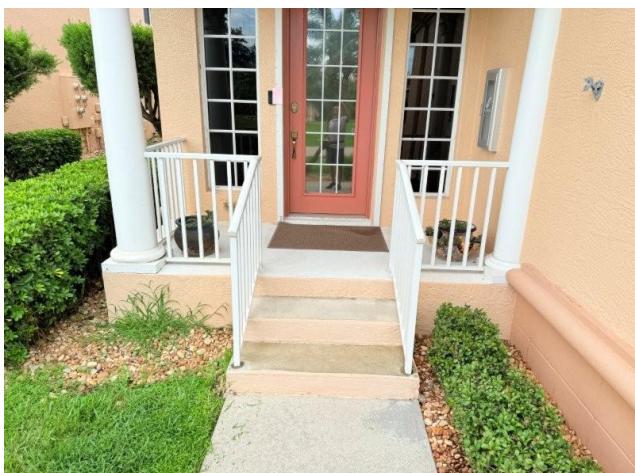
Handrails, Aluminum Picket

Unit Cost (01/01/2026): \$120.00
 Total Qty to Maintain (100% of Total): 477 LF
 Total Current Cost: \$57,240
 Inflation Rate: 2.50%
 Condition: Good

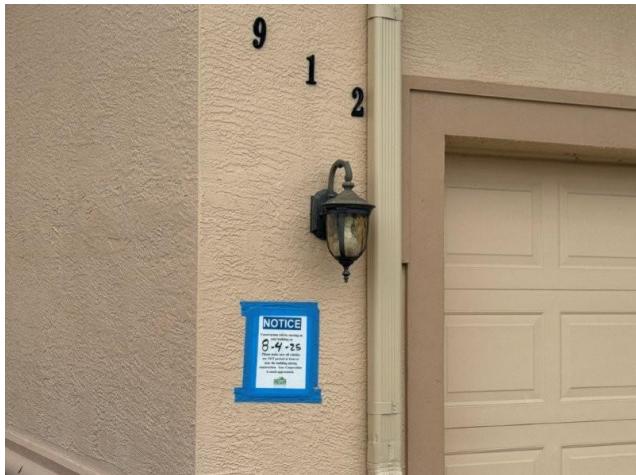
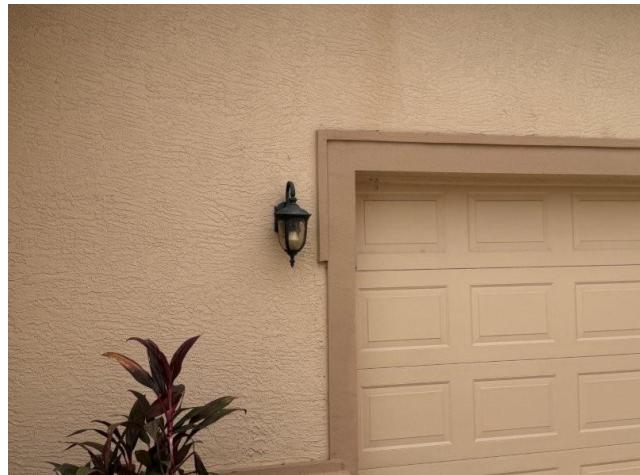
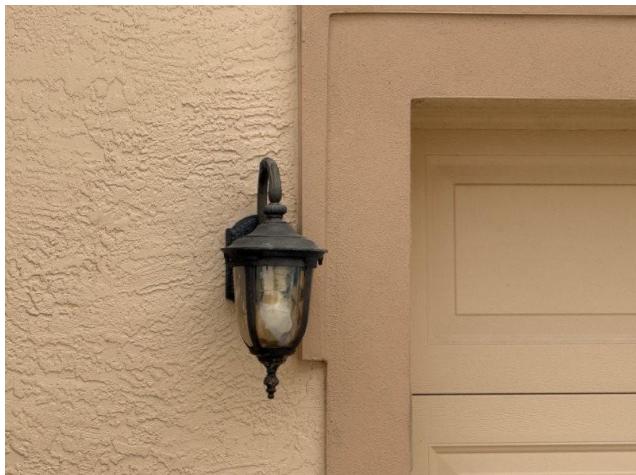
Light Fixtures, Exterior, Wall Mount

Unit Cost (01/01/2026): \$125.00
 Total Qty to Maintain (100% of Total): 54 Ea
 Total Current Cost: \$6,750
 Inflation Rate: 2.50%
 Condition: Good

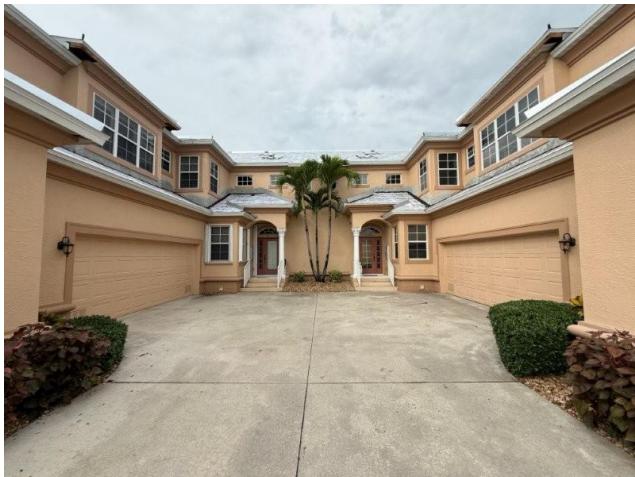
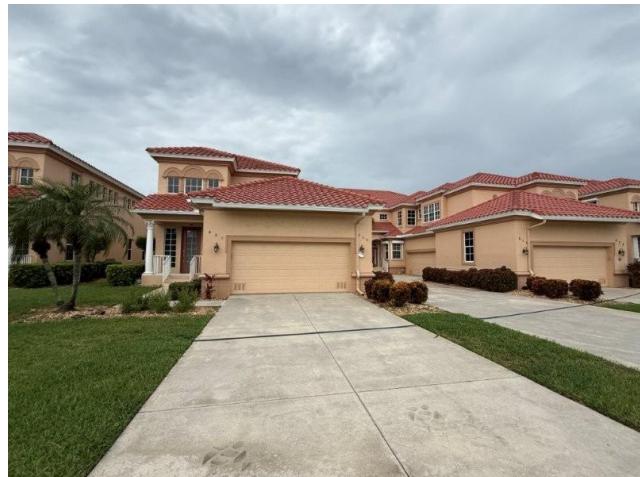
Pressure Washing, Buildings & Driveways

Unit Cost (01/01/2026): \$11,000.00
 Total Qty to Maintain (100% of Total): 1 Allow
 Total Current Cost: \$11,000
 Inflation Rate: 2.50%
 Condition: Good

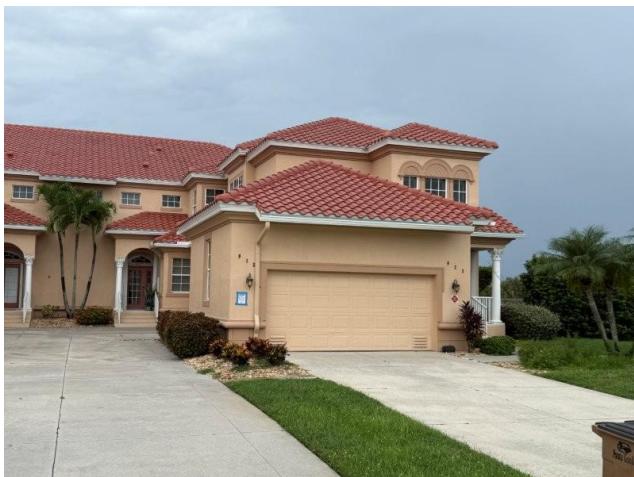
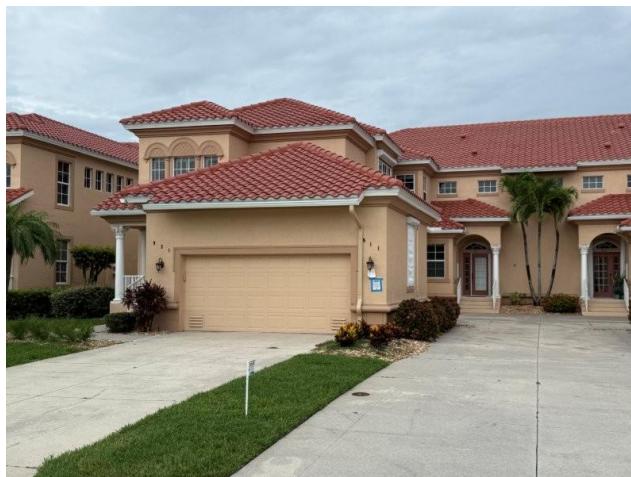
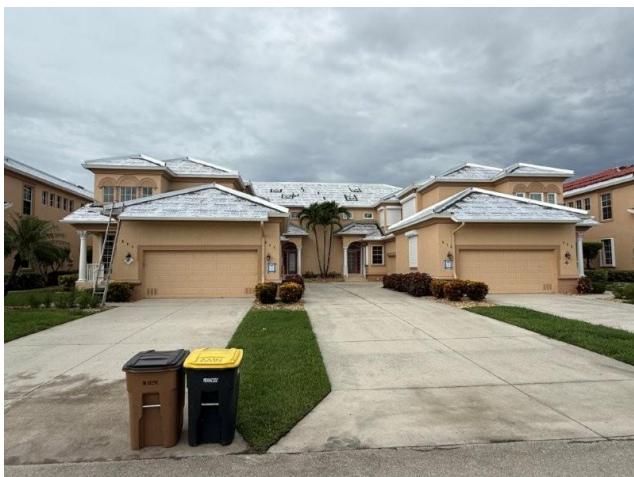
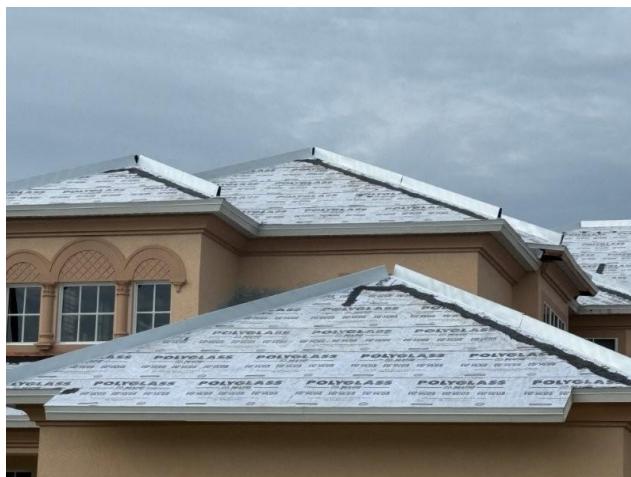
Roof, Concrete Tiles

Unit Cost (01/01/2026):	\$1,200,000.00
Total Qty to Maintain (100% of Total):	1 LS
Total Current Cost:	\$1,200,000
Inflation Rate:	2.50%
Condition:	Excellent

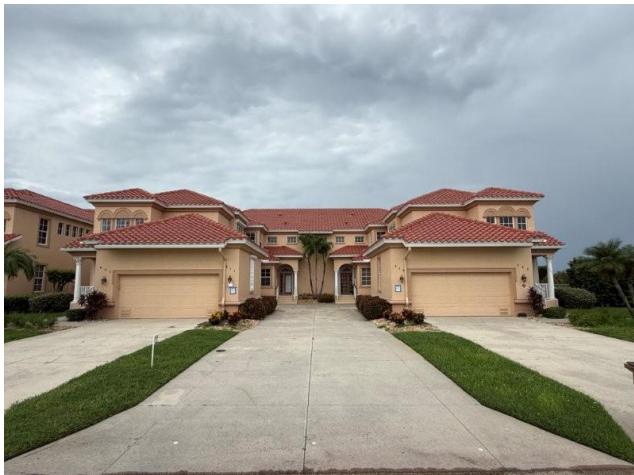
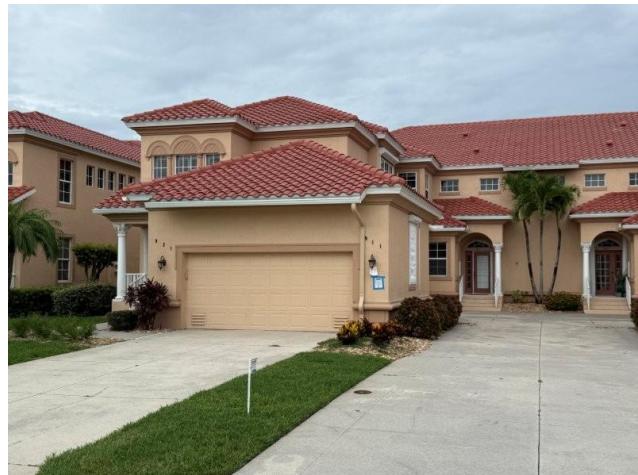
Roof, Maintenance & Cleaning

Basic Info		Cost Data	
Asset ID:	B07	Unit Cost (01/01/2026):	\$25,110.00
Type of Cost:	Repairs & Maintenance	Total Qty to Maintain (100% of Total):	1 LS
Category:	Exterior Building Components	Total Current Cost:	\$25,110
Sub Category:		Inflation Rate:	2.50%
Est. Useful Life:	3y	Condition:	Good

1. Roof Inspection & Maintenance will occur twice per year, before and after Hurricane Season.
2. Inspect roof for any potential tile or leak causing areas.

3. Will replace up to 10 broken tiles per building.
4. Caulk up to 100 linear feet of roof penetrations.
5. Caulk, moisten and seal all roof ventilation penetrations. This includes all goose necks, vents, pipe boots and off ridge vents.

8. Storage of excess tile for future replacement and repairs.
9. Priority service post storm & preferred EMS rates (if necessary).
10. Remove all debris.

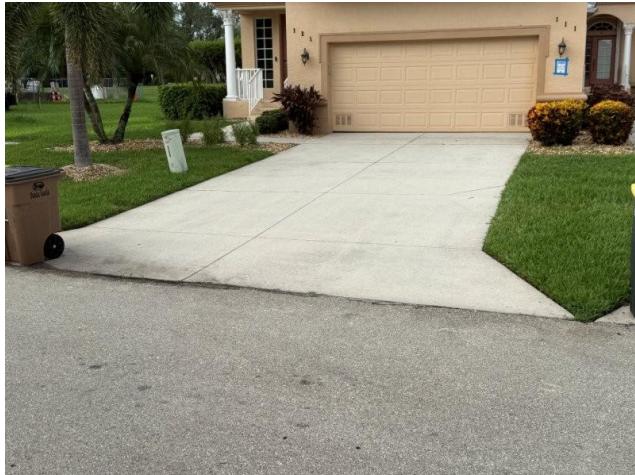
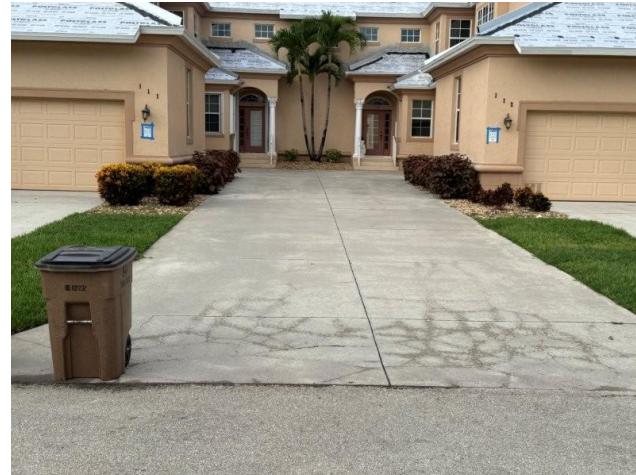
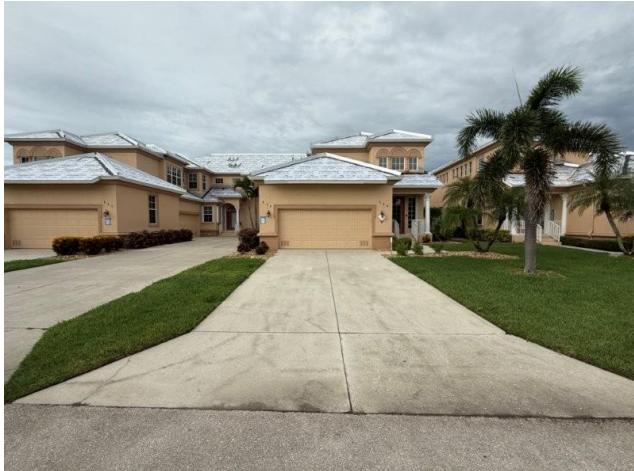
Basic Info		Cost Data	
Asset ID:	C01	Unit Cost (01/01/2026):	\$16.50
Type of Cost:	Replacement	Total Qty to Maintain (100% of Total):	6,444 SF
Category:	Property Site Components	Total Current Cost:	\$106,326
Sub Category:		Inflation Rate:	2.50%
Est. Useful Life:	50y	Condition:	Good

Component Details				
Total Driveways, Concrete, by Failure Rate Area	Cost per Sq Ft	Total Cost	50 Yr Life Failure Rate	Reserve Requirement
28,638	\$16.50	\$472,527	25%	\$118,131.75
Reserve Schedule				
Years	Reserve Amount	Sq Ft		
Years 1-10	No reserves			
Years 11-20	\$11,813	716		
Years 21-30	\$23,626	1,432		
Years 31-40	\$35,440	2,148		
Years 41-50	\$47,253	2,864		
Total	\$118,131.75			
Years 51-60	\$59,066	3,580		
Years 61-70	\$295,329	17,899

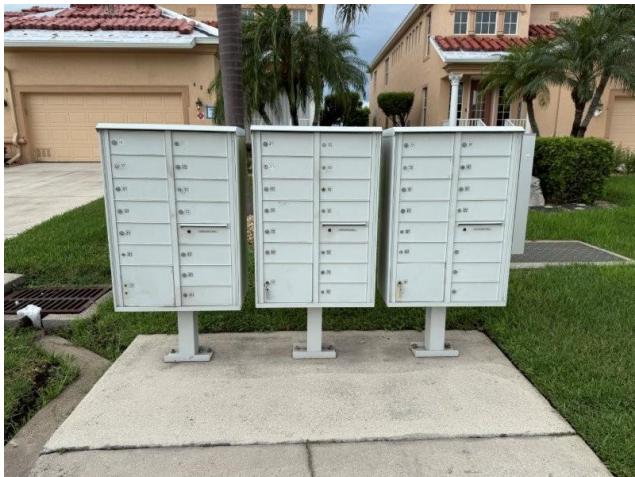
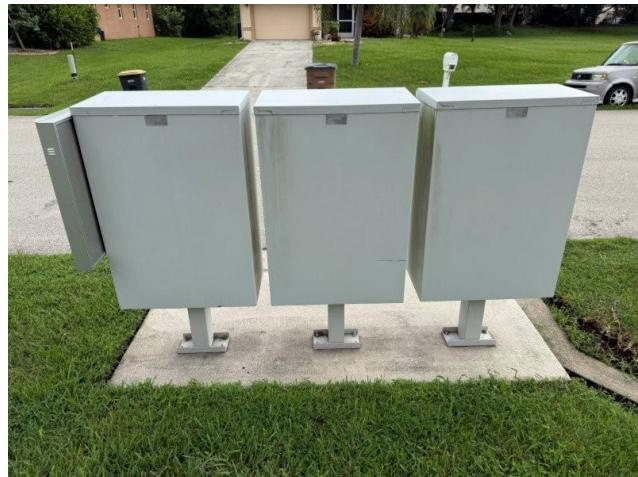
Mailbox Clusters, Aluminum, Multi-Tenant

Unit Cost (01/01/2026): \$3,450.00
 Total Qty to Maintain (100% of Total): 3 LS
 Total Current Cost: \$10,350
 Inflation Rate: 2.50%
 Condition: Good
